NATIONAL HISTORIC SITE / TEXAS

HISTORIC RESOURCE STUDY
FORT DAVIS NATIONAL HISTORIC SITE

By
Jerome A. Greene

November 1986

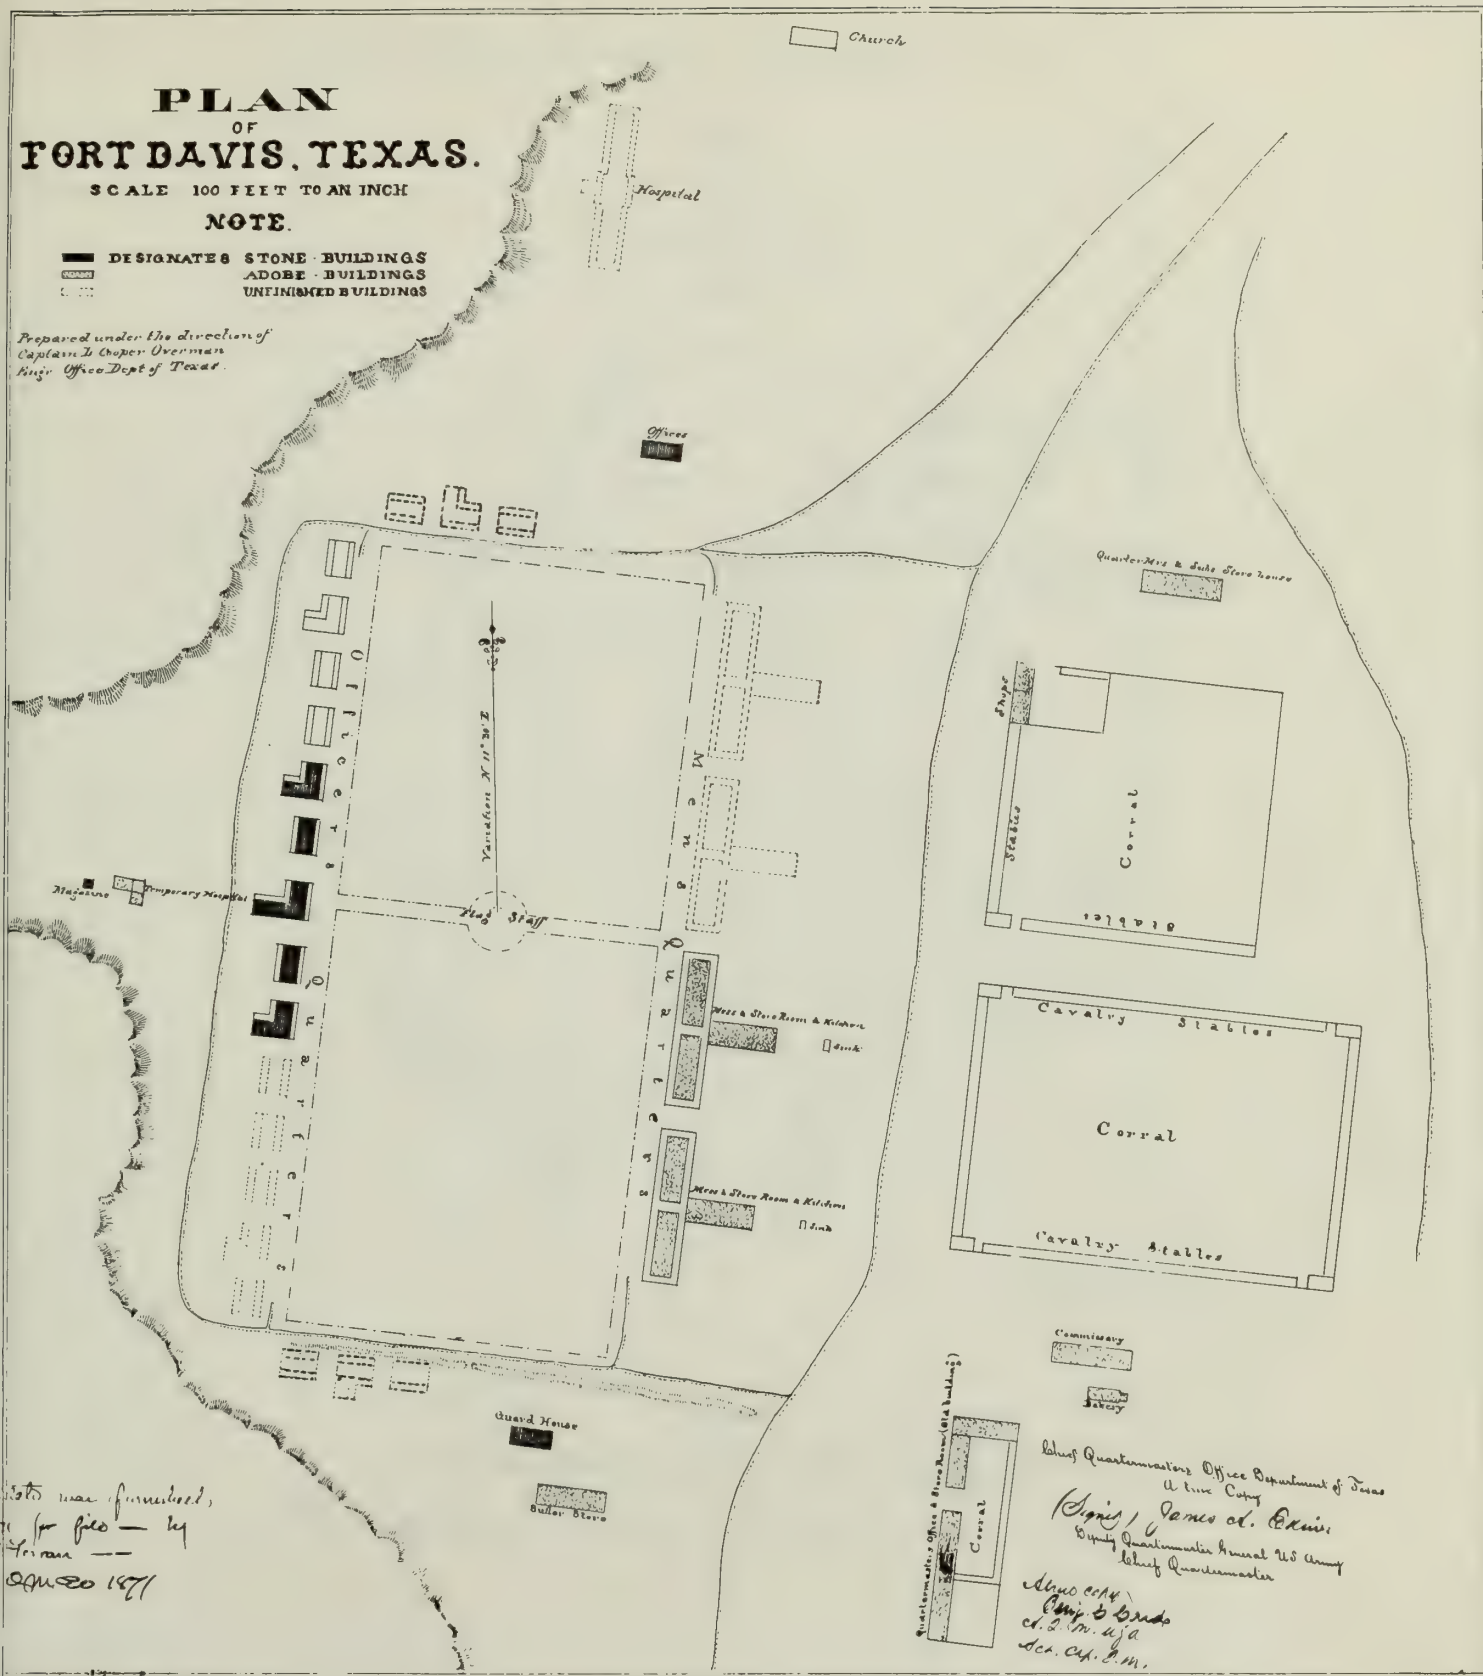
Illustration No. 23

"Plan of Fort Davis, Tex.," ca. 1871.

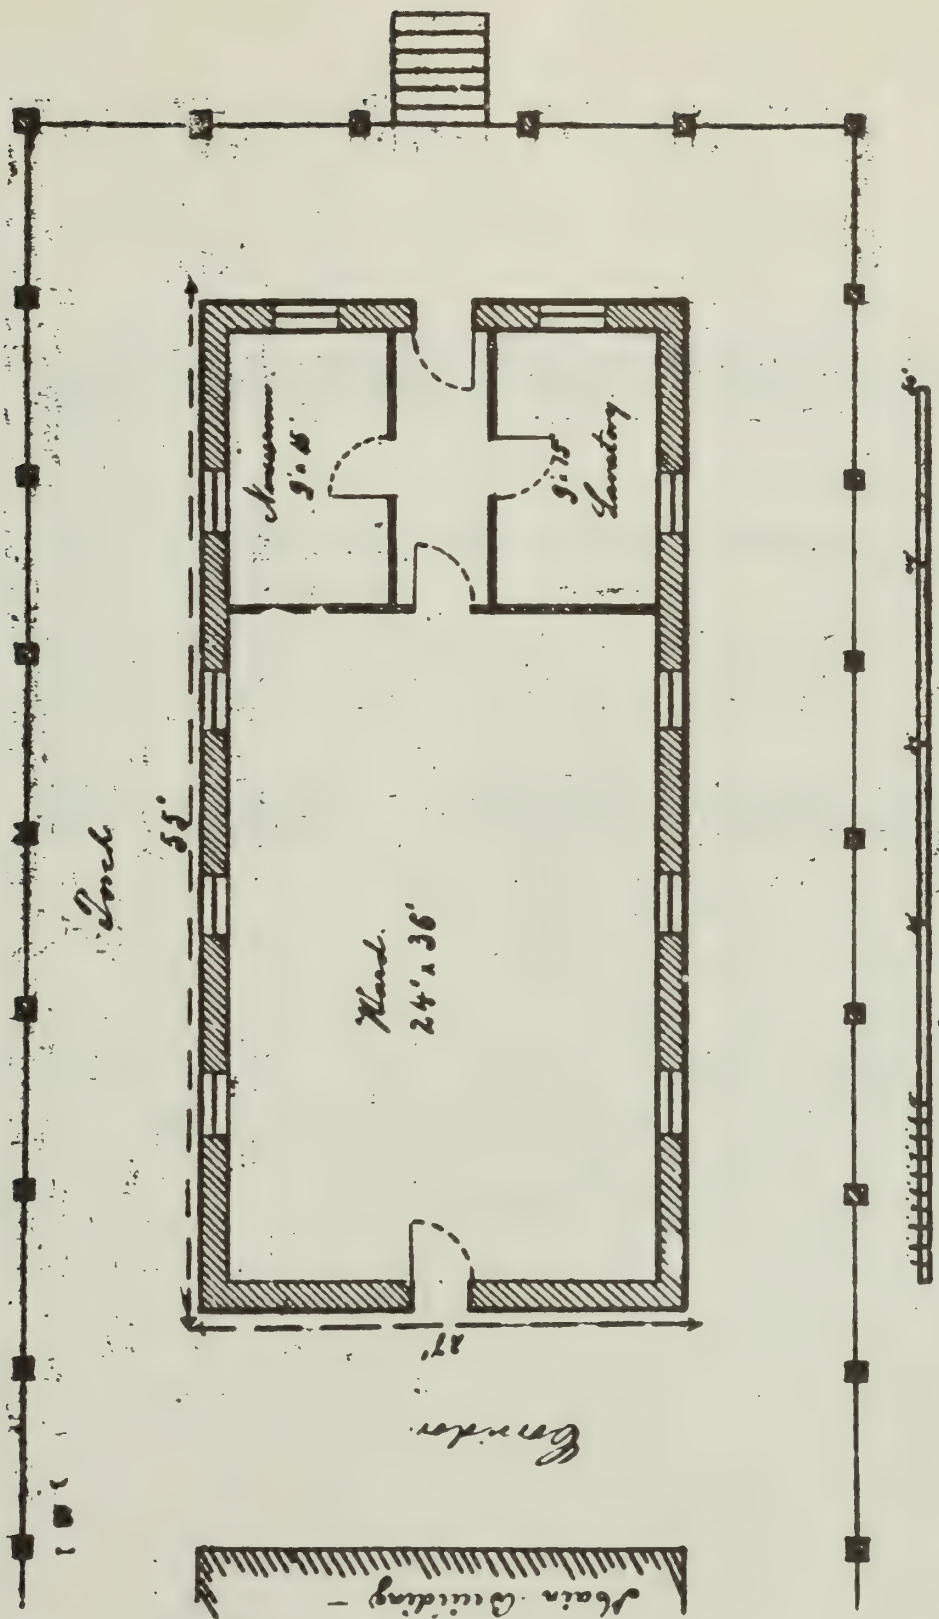
Illustration No. 34

Plan of addition to Post Hospital, 1883.
National Archives.

Ground Plan of additional Ward to Post-Hospital.
Fort Davis, Texas.

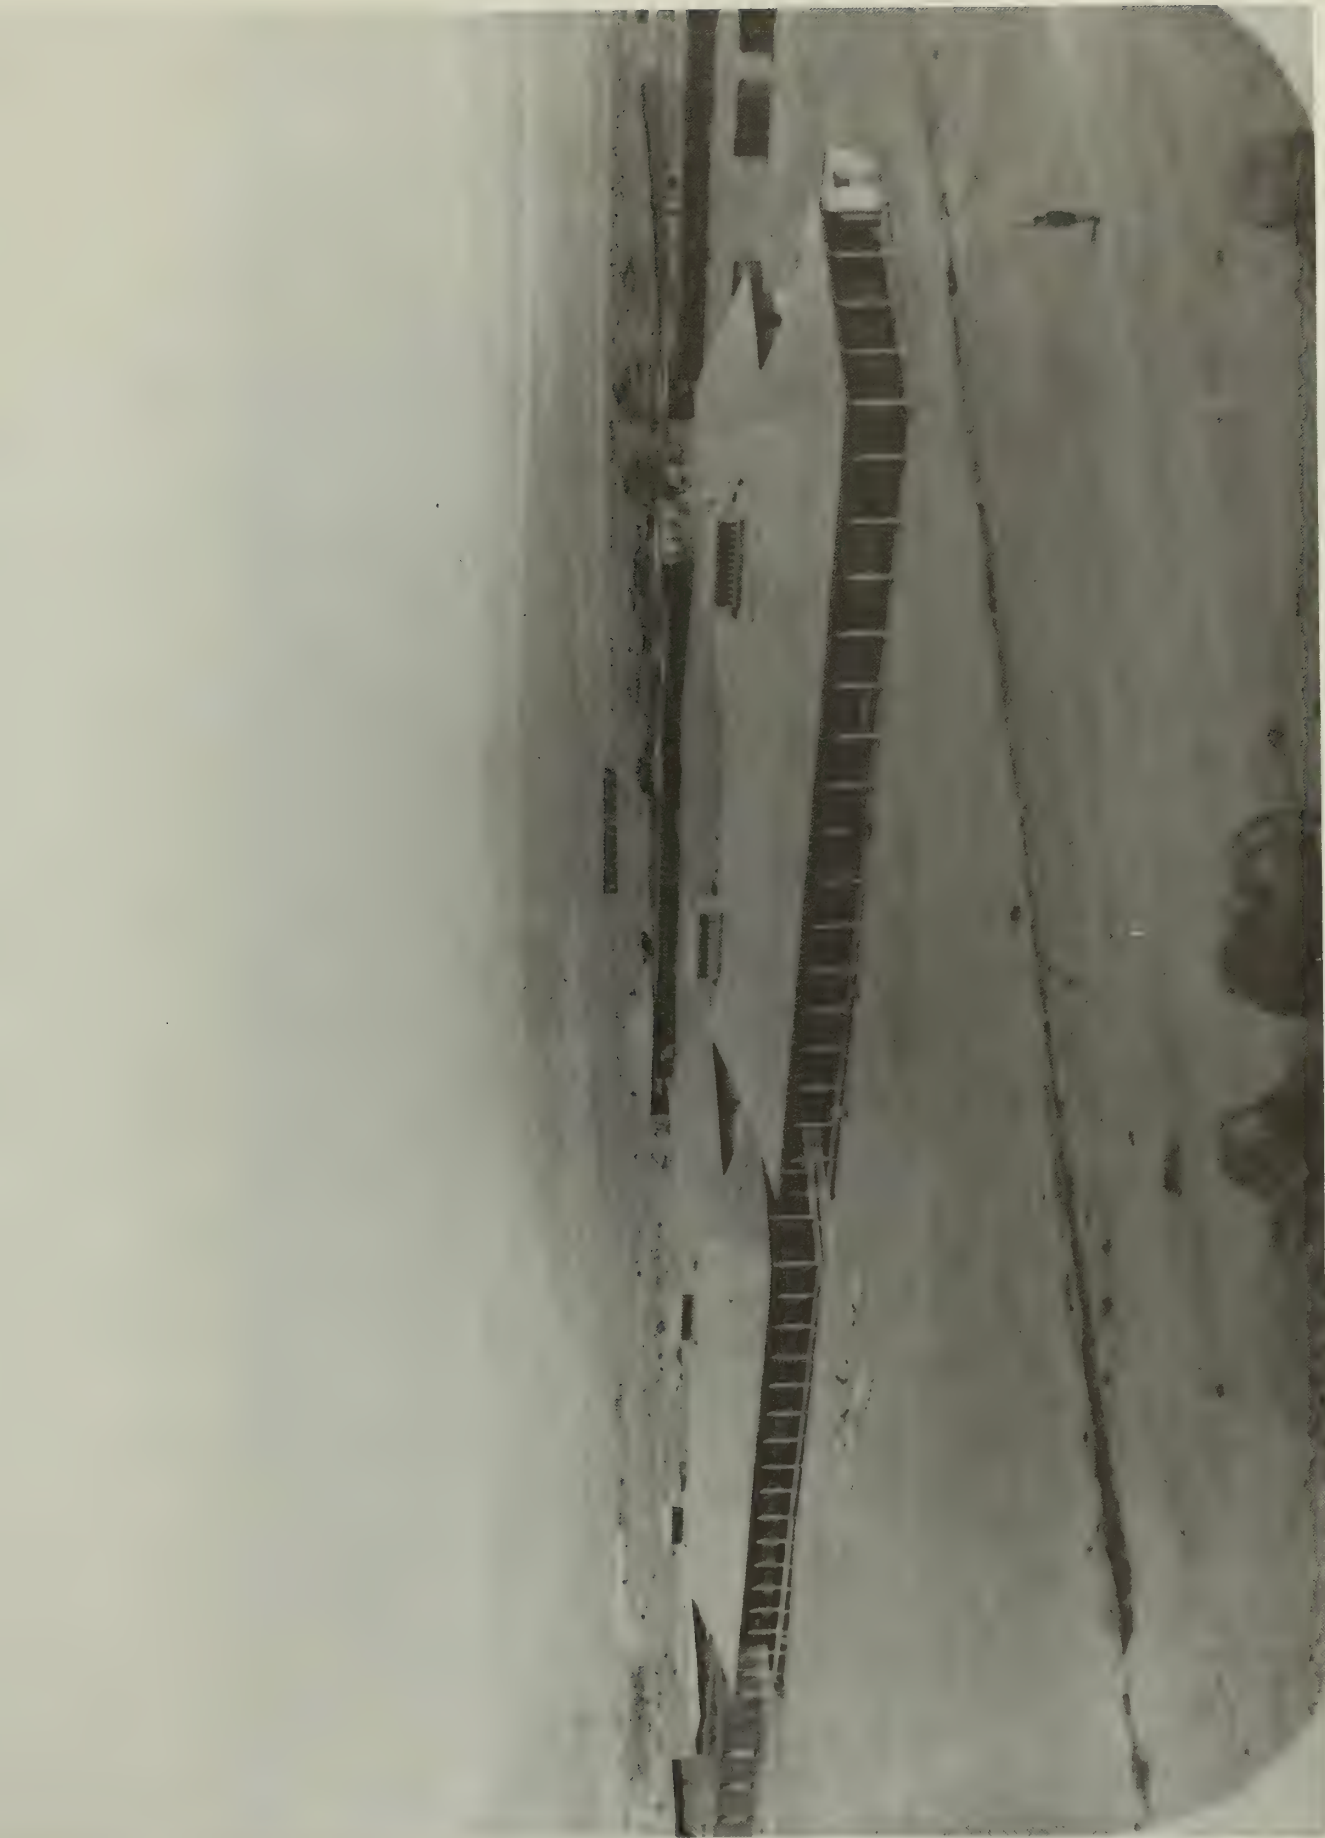
Illustration No. 44

Barracks HB-20 and HB-21, 1875. Unfinished Barracks HB-23 is at left, while the Quartermaster Corral (HB-40) and Cavalry Corral (HB-41) are in rear.

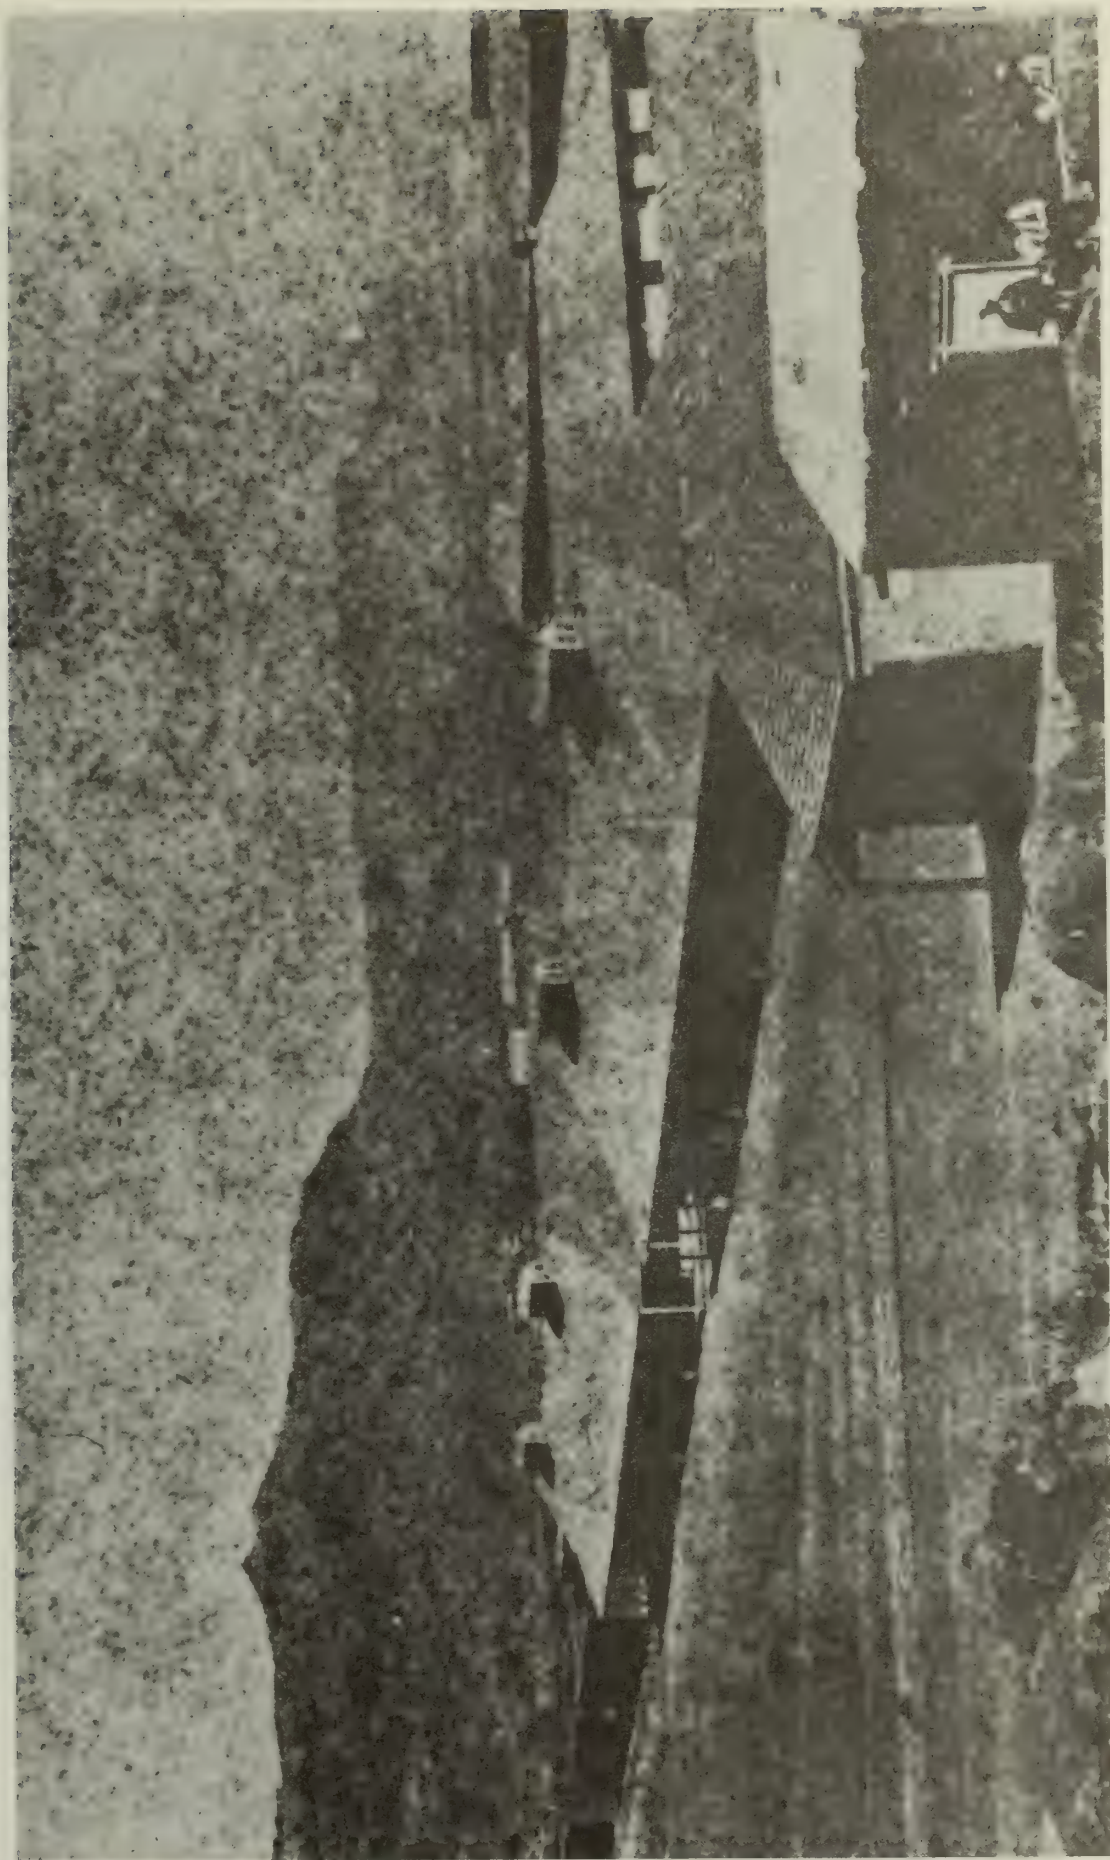
Illustration No. 45

View of post ca. 1875. Trader's Store (HB-49) is at right, behind first Guard House. Barracks HB-20 and HB-21 are at center. Unfinished barracks HB-22 and HB-23 appear at left.

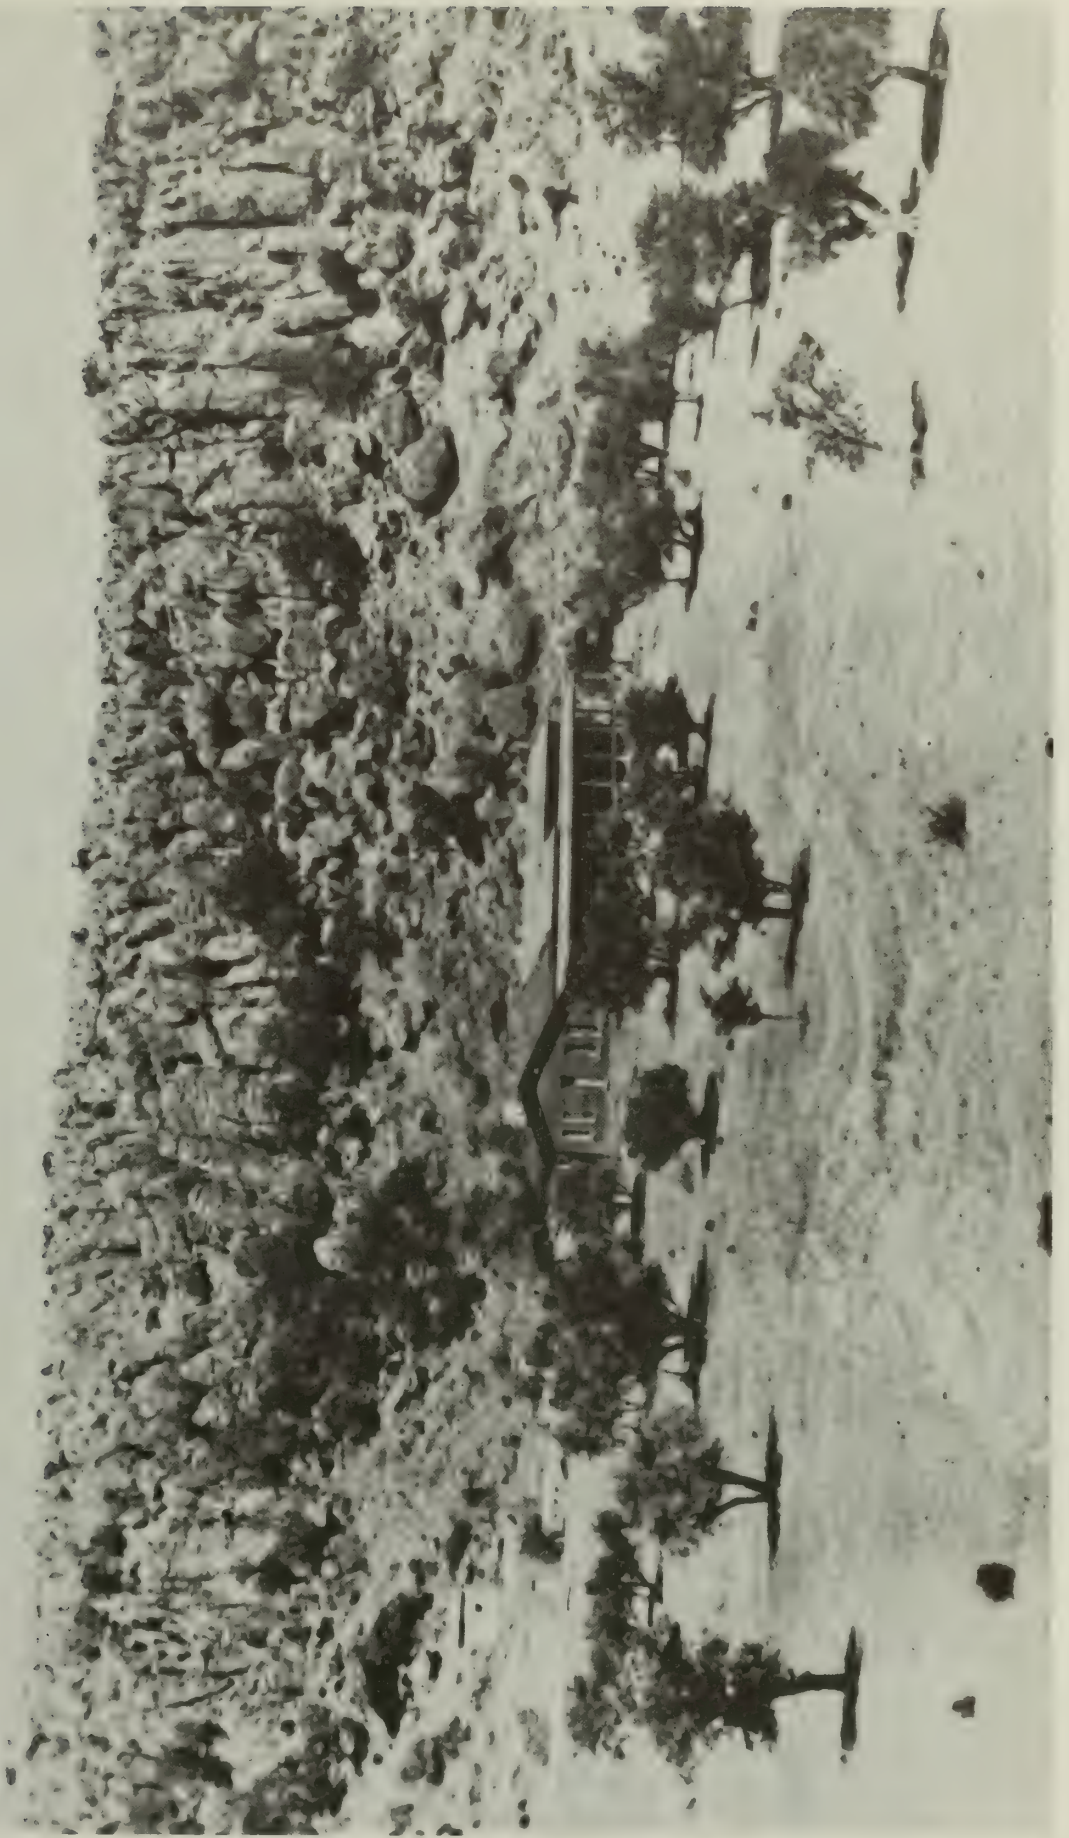
Illustration No. 48

Post Hospital (HB-46), ca. 1876-80, before south ward was added.

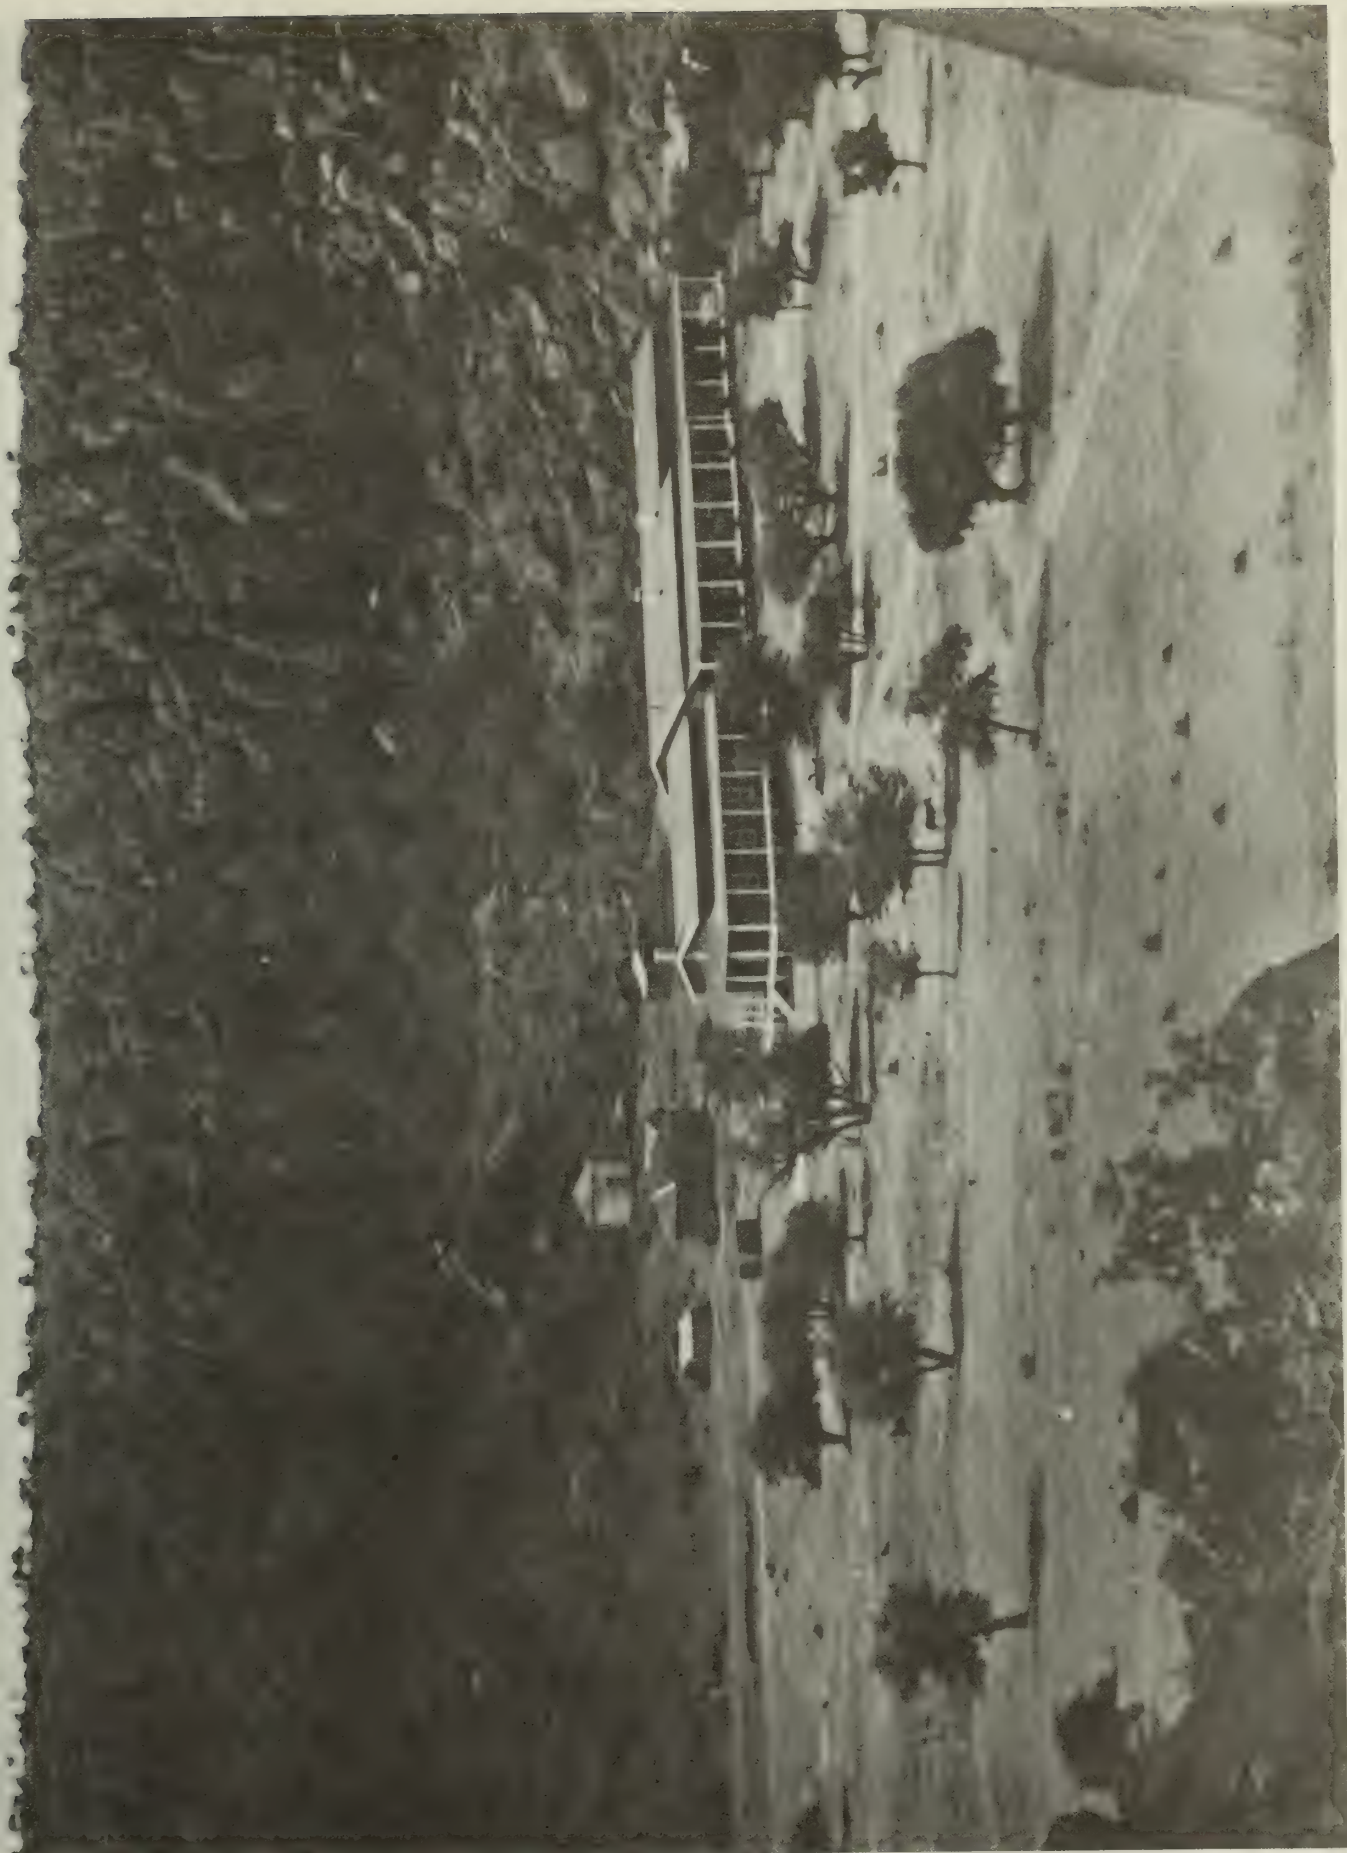
Illustration No. 51

Post Hospital complex (HB-46-50), ca. 1885-88. Magazine
(HB-49) is at base of cliff.

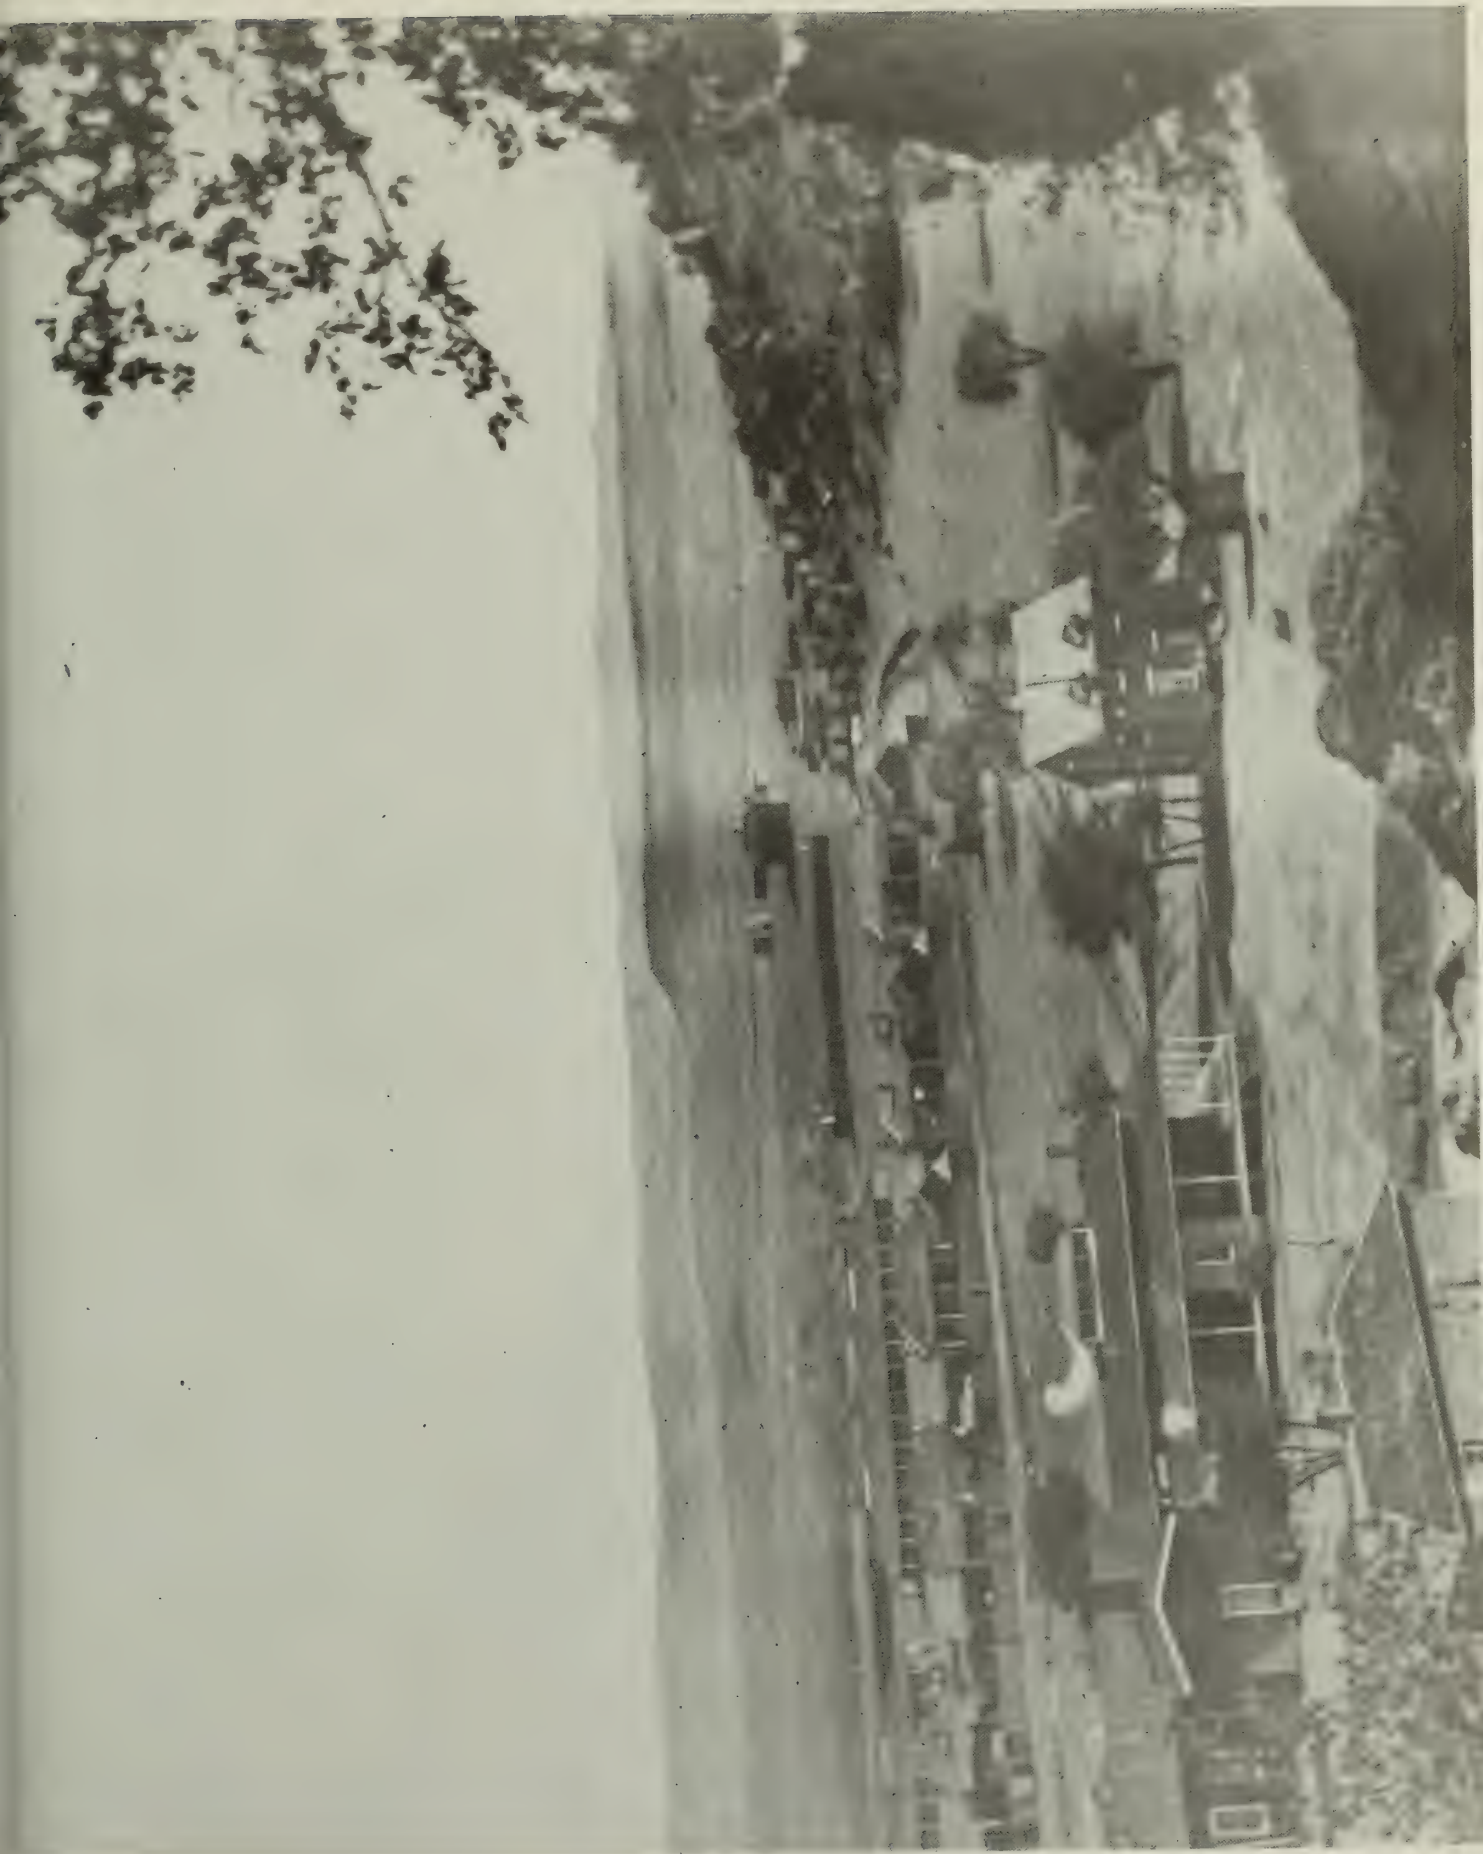
Illustration No. 60

Fort Davis from the west, ca. 1889. Note drainage ditch in foreground and behind Officers' Row.

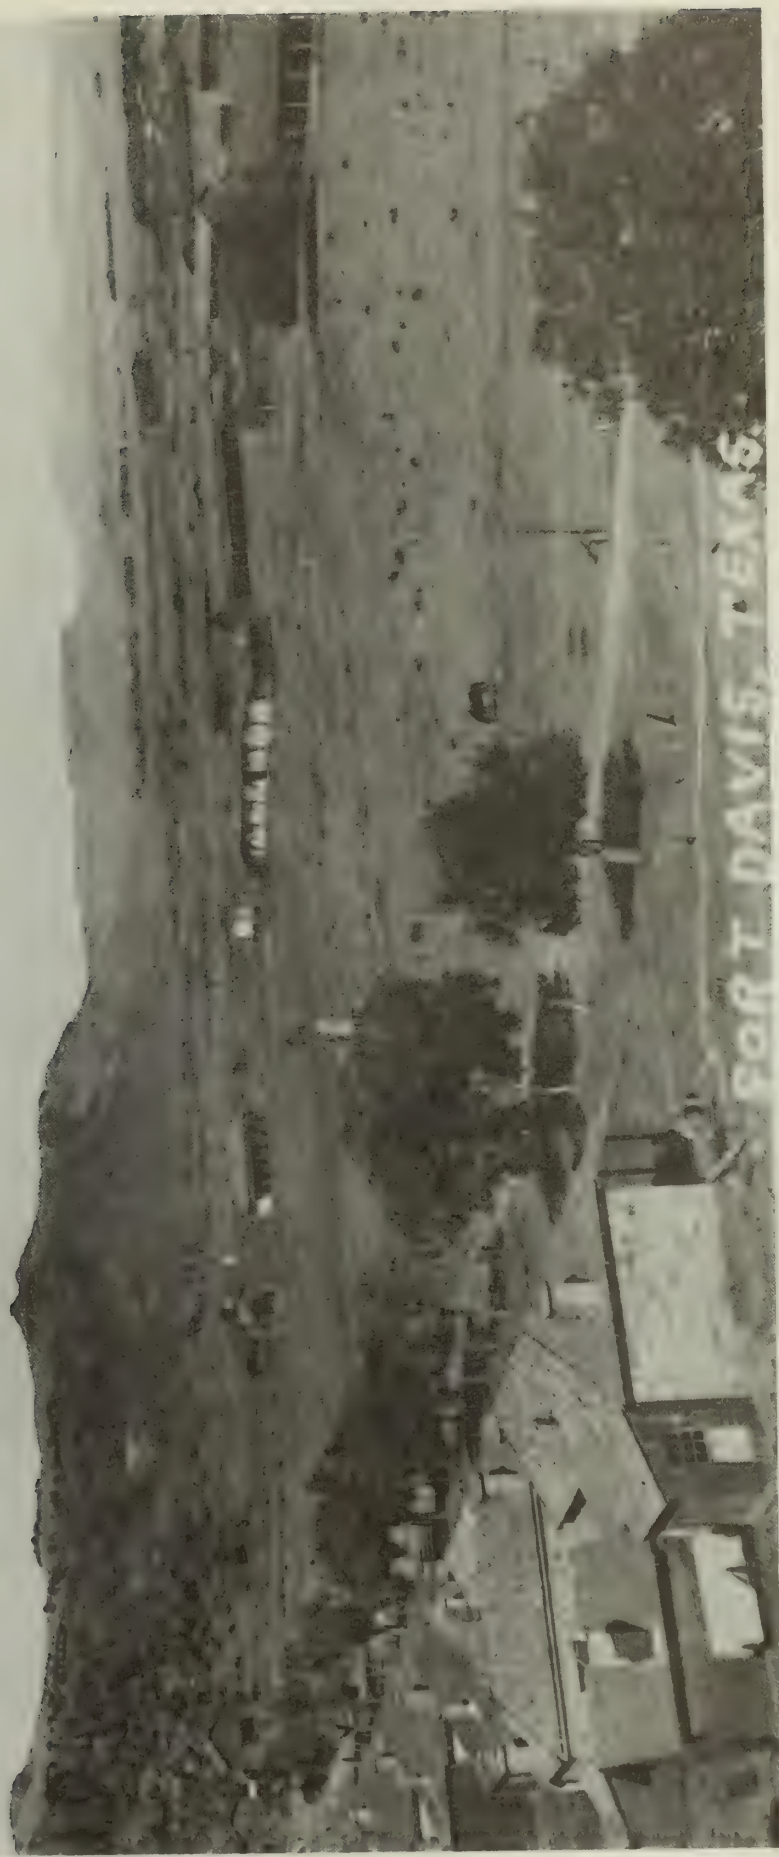
Illustration No. 79

Fort Davis, ca. 1910-15. View from southwest. Barracks
HB-22 has been demolished.
